Annual inspection report

Norton on Derwent Town Council play areas at

Burdale Close, Norton, Malton, North Yorkshire, YO17 9DG &

King George Playing Field, Eastfield Road, Norton, Malton,
North Yorkshire, YO17 9JS

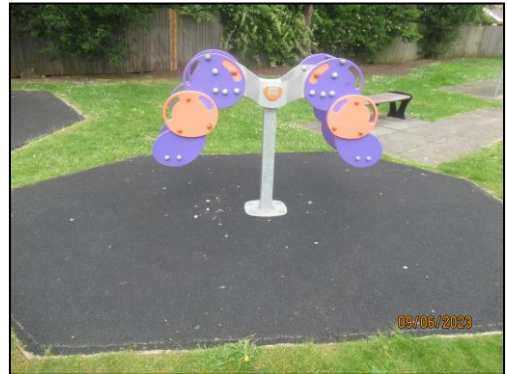
Surface Compliance: BS EN 1176-1, Sec. 4.2.8.5.2, flange on ground fixing infringes on impact area, also edgings infringe on impact area (actually 1.3m to side, should be at least 1.5m)

(Exposed ground fixing in impact area – library photo)

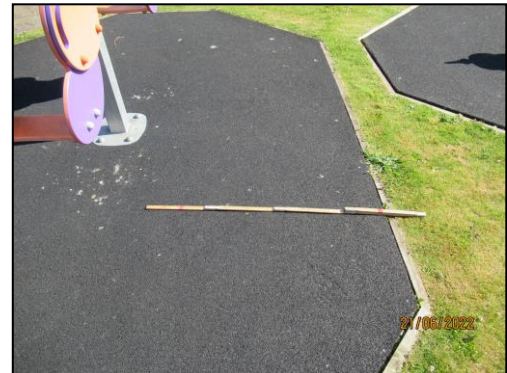
(Edgings in impact area – library photo)

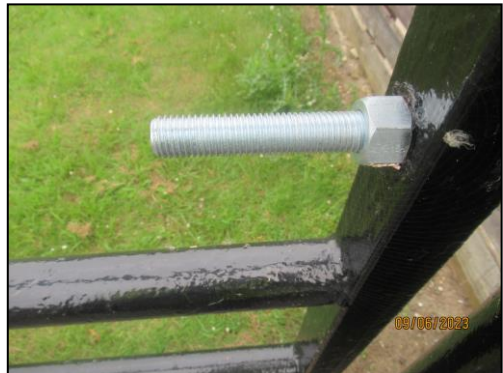
Vehicular Access Gate x one – potential head trap between top 2 bars. **Remove excess bolt thread (Low Risk)**

(Excess bolt thread at vehicular access gate)

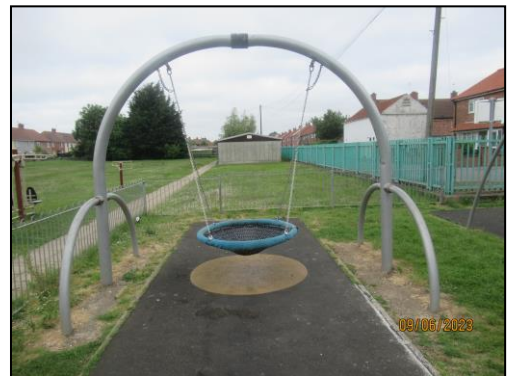
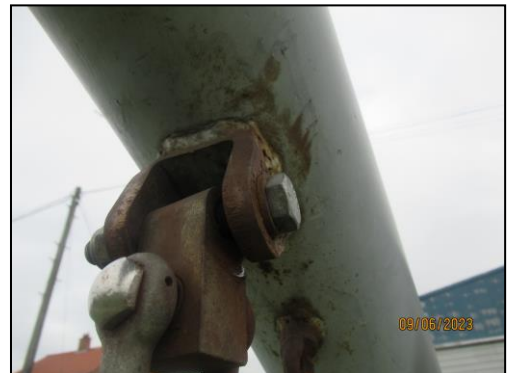
1. Hags Group Swing

Condition: Replace worn bushes in chain bearing blocks
A.S.A.P. (as per email of 12/6/23)

Compliance: BS EN 1176-1, Sec. 4.2.7.6, potential finger trap between plastic links on basket

(Worn bushes in chain bearing blocks)

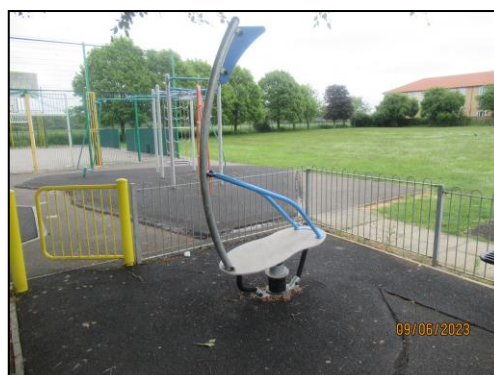
9. Sutcliffe Kite Surf

Compliance: BS EN 1176-1, Sec. 4.2.8.4, seat & fence infringe on falling space (actually 1.3m, should be at least 1.5m)

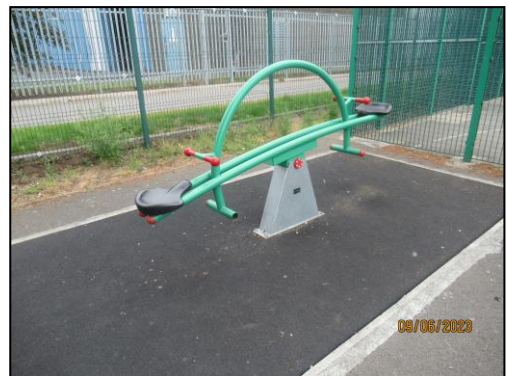
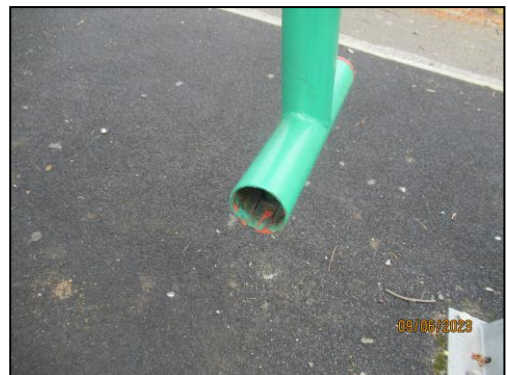
11. Sutcliffe Seesaw

Condition: Replace one missing end cap on foot hold

(Missing end cap on foot hold)

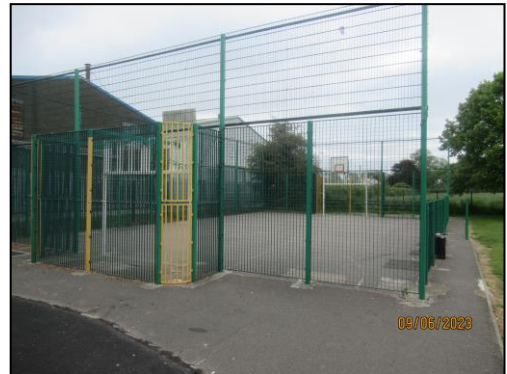
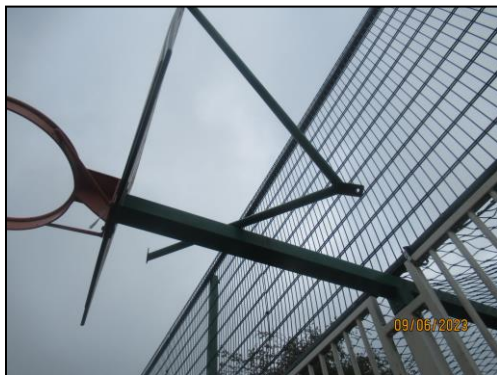
13. Hags Multi-use Games Area

Condition: Resecure basketball back board frame A.S.A.P. (as per email of 12/6/23)

(Loose basketball back board frame)

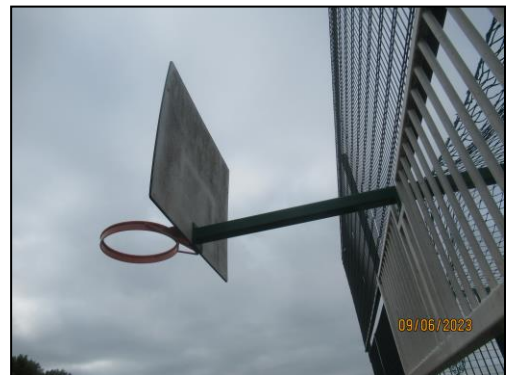
Replace one missing basketball back board frame

(Missing basketball back board frame)

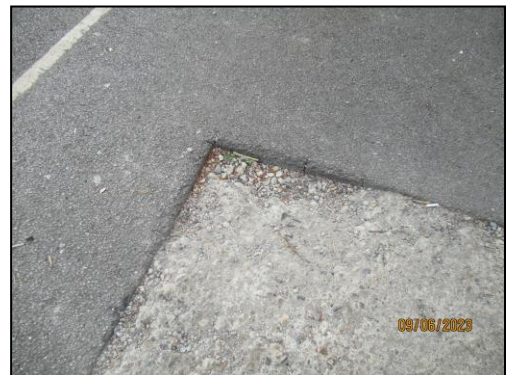
Surface Condition: Potential trip hazard in goal – requires attention (Medium Risk)

(Potential trip hazard in goal)

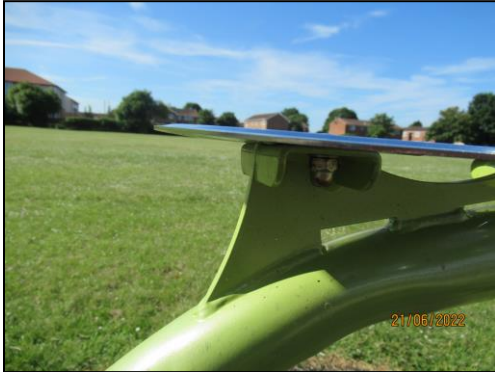
Compliance: BS EN 16630, Sec. 4.3.3, hard edge to two seats & backrest

(Hard edge at seat – library photo)

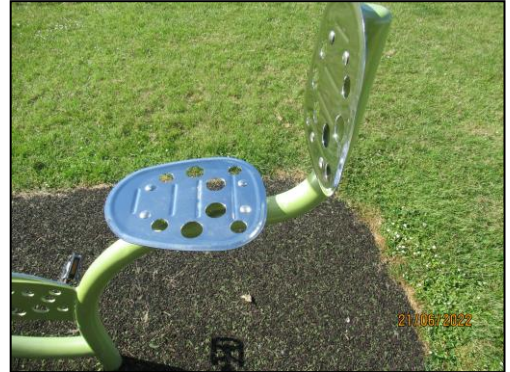
(Hard edge at seat backrest – library photo)

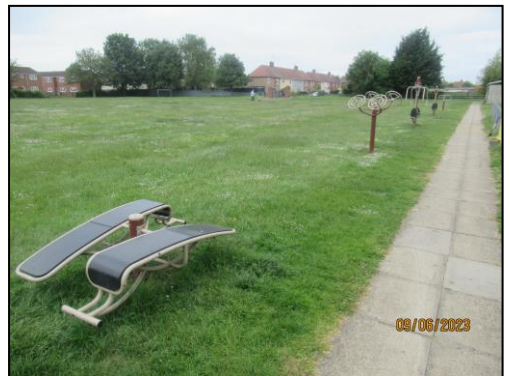
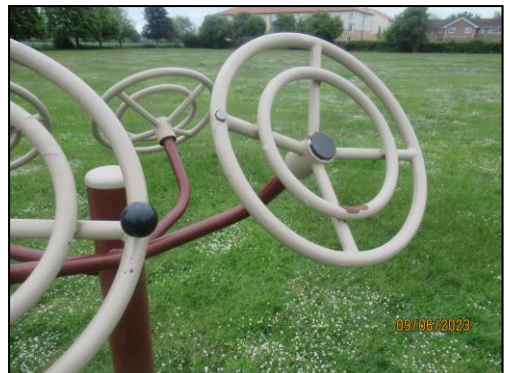
15. Hags Five-item Fitness Area

Condition: Lubricate bearings on hand wheels
Replace three missing hand holds on hand wheels

(Missing hand holds at hand wheels)

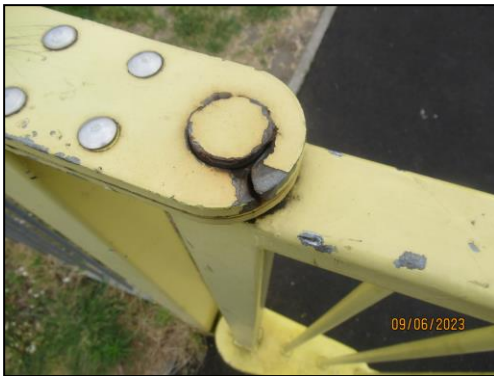
Pedestrian Gates x two – one gate not closing. **Repair broken hinge (Low Risk)** One gate locked – visual inspection only

(Broken hinge at gate)

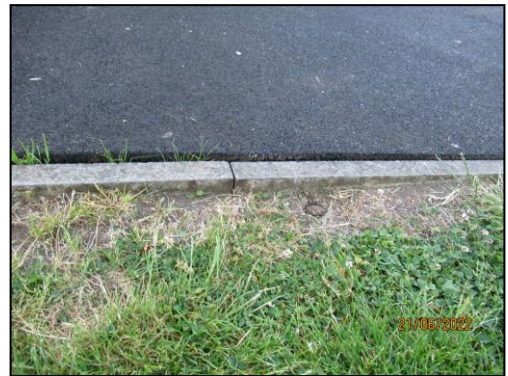
General area – **potential trip hazards at edgings of safer surface at various locations – requires attention. (Medium Risk)** Tidy

(Potential trip hazard at edgings – library photo)
