Annual inspection report

Norton on Derwent Town Council play areas at

Burdale Close, Norton, Malton, North Yorkshire, YO17 9DG &

King George Playing Field, Eastfield Road, Norton, Malton,
North Yorkshire, YO17 9JS

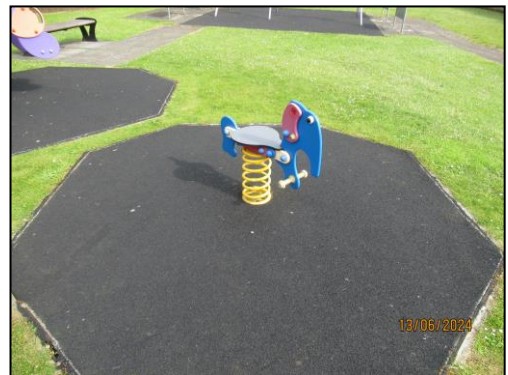
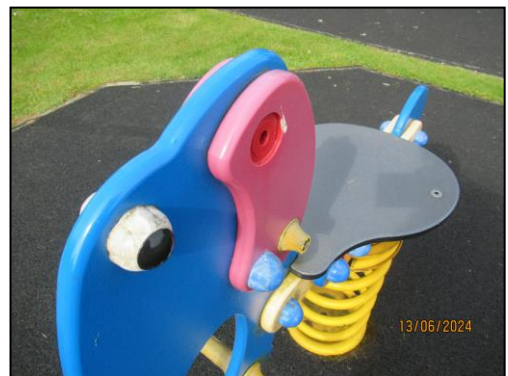
1. Playworld Systems Spring Elephant

Condition: Replace both missing handgrips

(Missing handgrips)

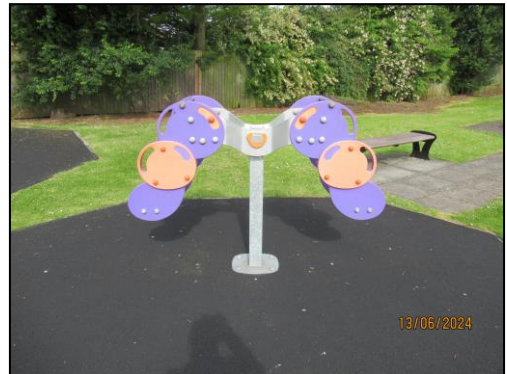
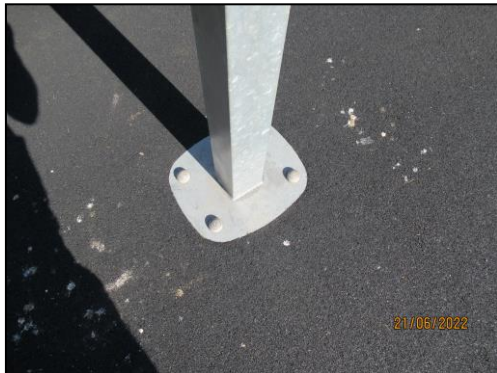
2. Streetscape Stand-on Rocker

Surface Compliance: BS EN 1176-1, Sec. 4.2.8.5.2, ground fixing infringes on impact area, also edgings infringe on impact area (actually 1.3m to side, should be at least 1.5m)

(Exposed ground fixing in impact area – library photo)

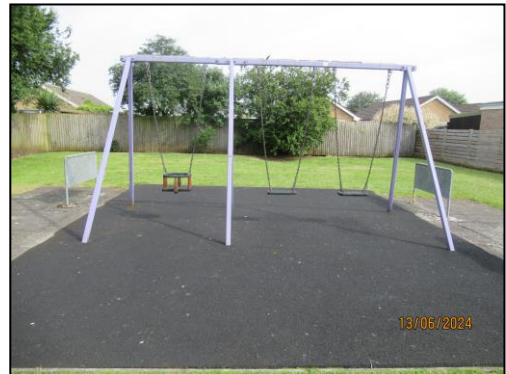
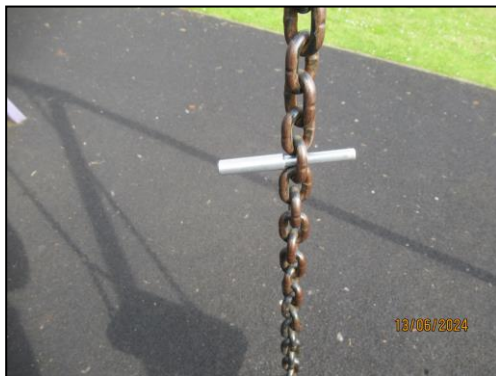
4. Streetscape 2.4m 2 Bay Swing with 1 Cradle Seat, 2 Flat Seats & Barriers

Compliance: BS EN 1176-1, Sec. 4.2.13, openings in chains exceed 8.6mm

(Openings in chains exceed 8.6mm)

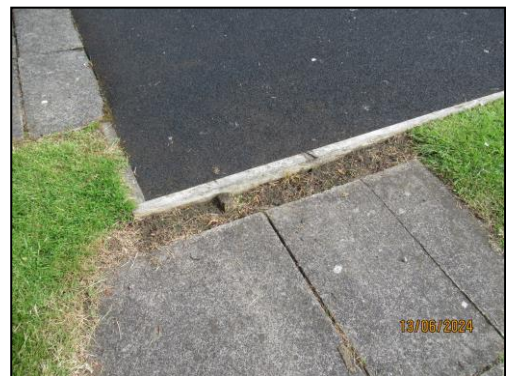
Surface Condition: Showing signs of shrinkage – monitor
Potential trip hazard at edgings – requires attention (Medium Risk)

(Potential trip hazard at edgings)

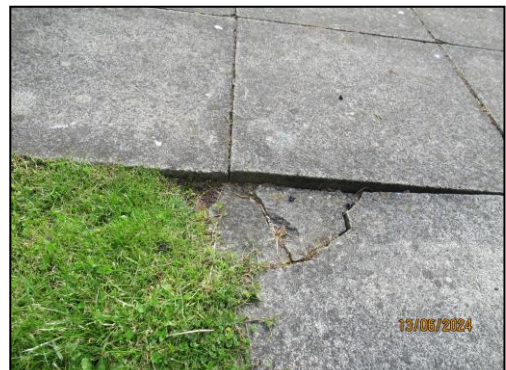
Path – **potential trip hazard at slabs adjacent to seat – requires attention (Medium Risk)**

(Potential trip hazard at slabs adj to seat)

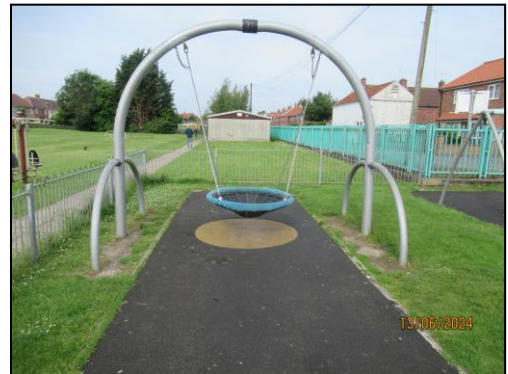
1. Hags Group Swing

Compliance: BS EN 1176-1, Sec. 4.2.7.6, potential finger trap between plastic links on basket

Surface Condition: Showing signs of shrinkage – monitor

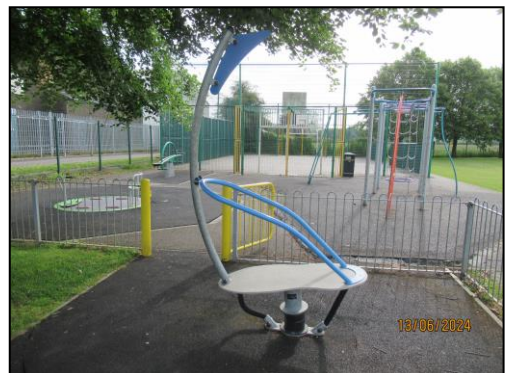
9. Sutcliffe Kite Surf

Compliance: BS EN 1176-1, Sec. 4.2.8.4, seat & fence infringe on falling space (actually 1.3m, should be at least 1.5m)

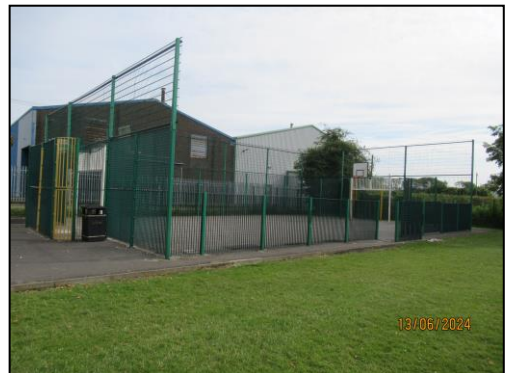
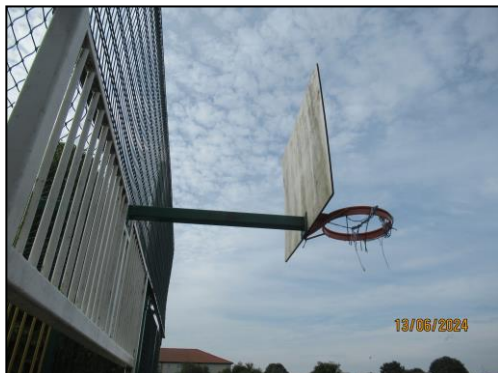
13. Hags Multi-use Games Area

Condition: Replace both missing basketball back board frames

(Missing basketball back board frame)

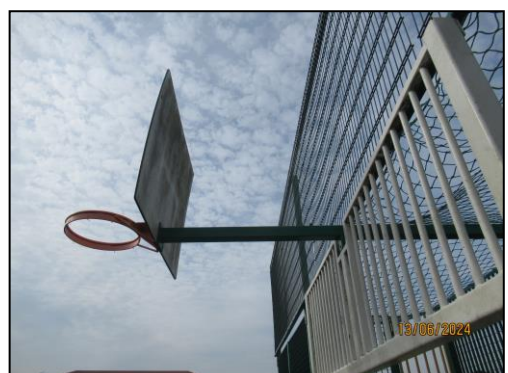
(Missing basketball back board frame)

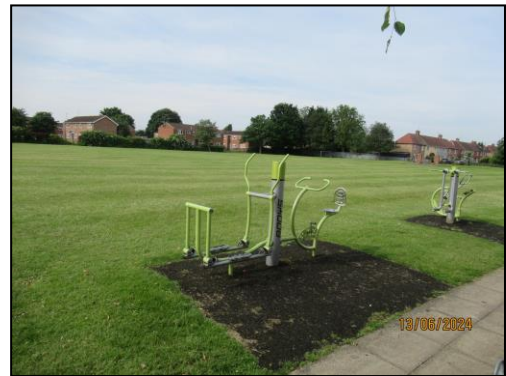
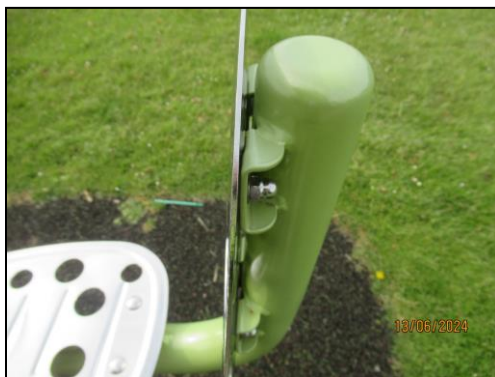
14. Bodys Four-item Fitness Station

Compliance: BS EN 16630, Sec. 4.3.3, hard edge to two seats & backrest

(Hard edge at seat backrest)

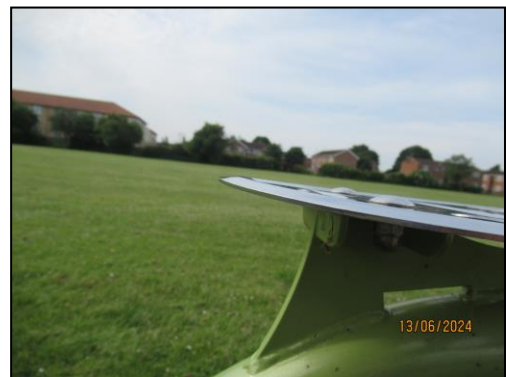
(Hard edge at seat)

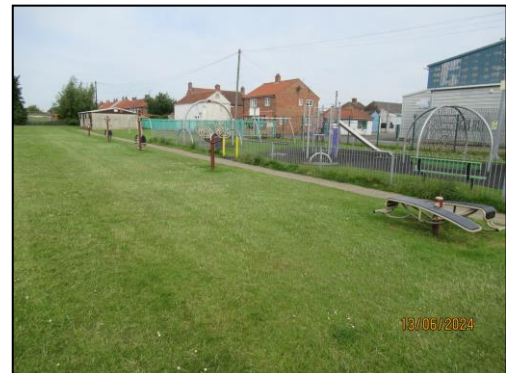
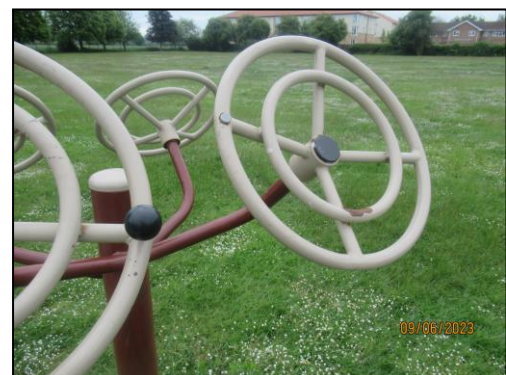
15. Hags Five-item Fitness Area

Condition: Lubricate bearings on hand wheels
Replace three missing hand holds on hand wheels
One wheel not turning – replace broken bearing

(Missing hand holds at hand wheels – library photo)

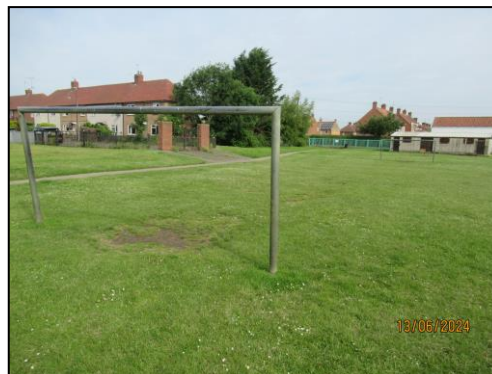
16. Unknown Make Two 5-a-side Goals

Surface Condition: Worn in goals – monitor

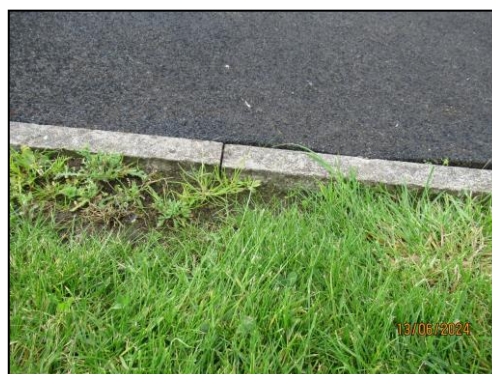
General area – **potential trip hazards at edgings of safer surface at various locations – requires attention. (Medium Risk)** Tidy

(Potential trip hazard at edgings)
