Annual inspection report

Norton on Derwent Town Council play areas at

Burdale Close, Norton, Malton, North Yorkshire, YO17 9DG &

King George Playing Field, Eastfield Road, Norton, Malton,
North Yorkshire, YO17 9JS

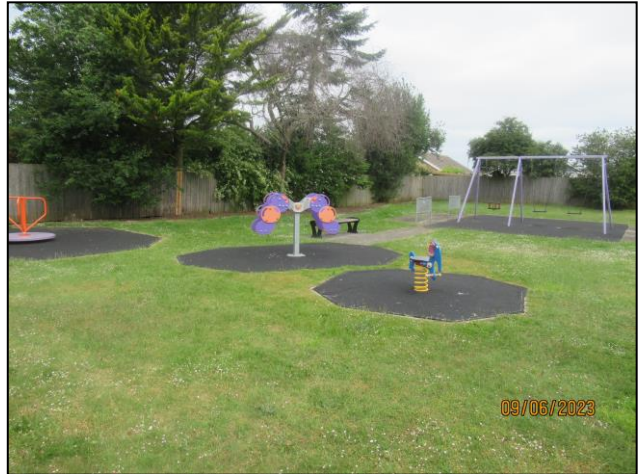
1. Playworld Systems Spring Elephant

Condition: No defects were found

Compliance: Complies with BS EN 1176

Surface Condition: Satisfactory

Surface Compliance: Meets the dimensional requirements of
BS EN 1176

Very Low Risk: 2

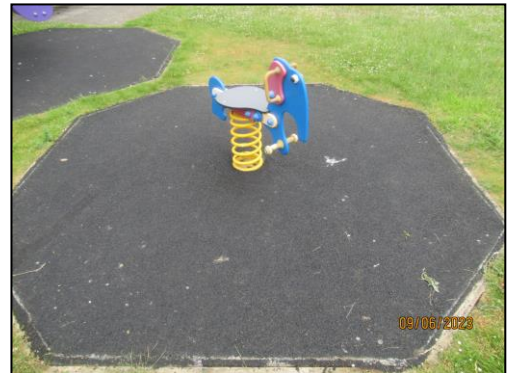
2. Streetscape Stand-on Rocker

Condition: No defects were found

Surface Condition: Satisfactory

Surface Compliance: BS EN 1176-1, Sec. 4.2.8.5.2, flange on ground fixing infringes on impact area, also edgings infringe on impact area (actually 1.3m to side, should be at least 1.5m)

Medium Risk: 8

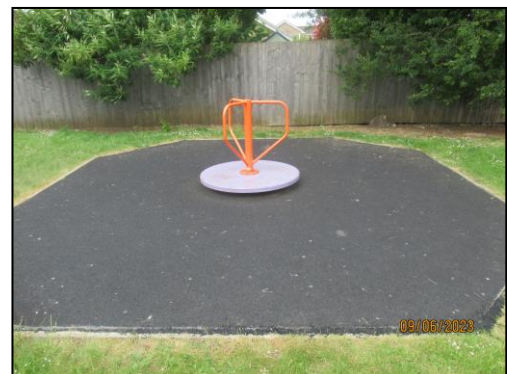
3. Streetscape Roundabout

Condition: No defects were found

Surface Condition: Satisfactory

Surface Compliance: Meets the dimensional requirements of BS EN 1176

Low Risk: 4

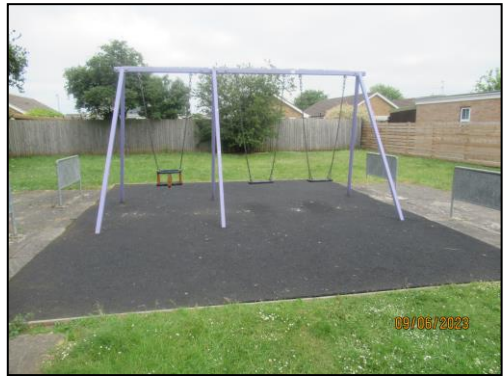
4. Streetscape 2.4m 2 Bay Swing with 1 Cradle Seat, 2 Flat Seats & Barriers

Condition: No defects were found

Surface Condition: Showing signs of shrinkage – monitor

Surface Compliance: Meets the dimensional requirements of BS EN 1176

Low Risk: 5

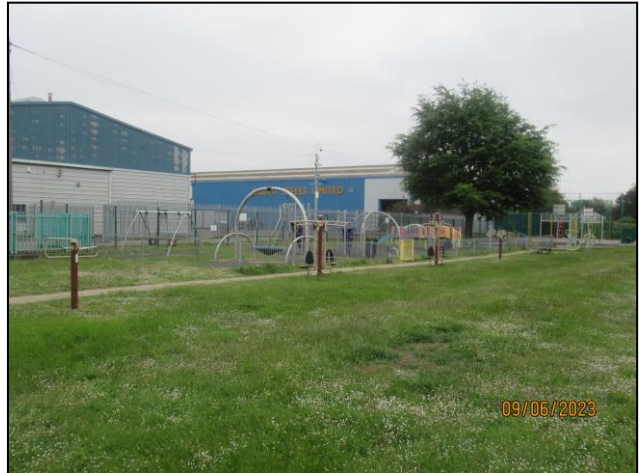
1. Hags Group Swing

Condition: Replace worn bushes in chain bearing blocks
A.S.A.P. (as per email of 12/6/23)

Compliance: BS EN 1176-1, Sec. 4.2.7.6, potential finger trap between plastic links on basket

Surface Condition: Showing signs of shrinkage – monitor

Low Risk: 6

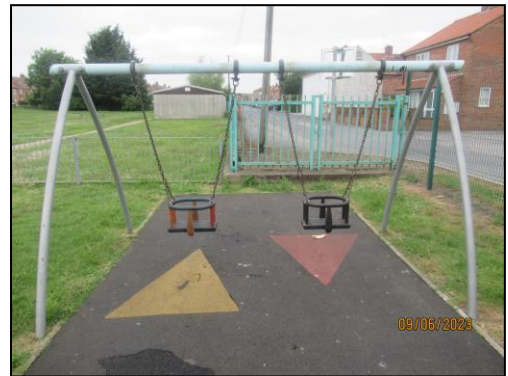
2. Hags 1.8m 1 Bay Swing with 2 Cradle Seats

Condition: No defects were found

Surface Condition: Showing signs of shrinkage – monitor

Very Low Risk: 2

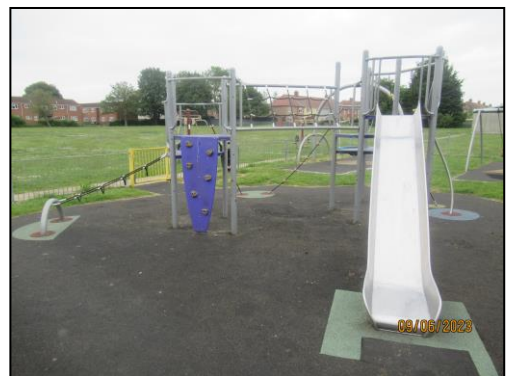
3. Hags Junior Multi Unit

Condition: No defects were found

Surface Condition: Showing signs of shrinkage – monitor

Low Risk: 7

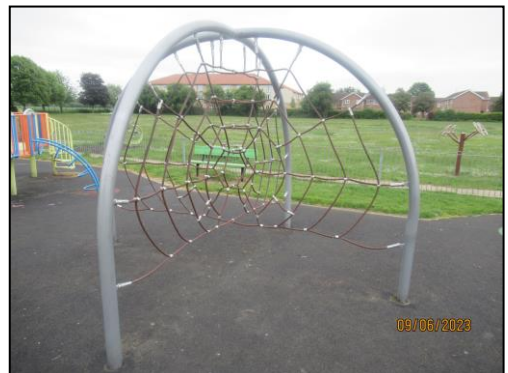
4. Hags Net Climber

Condition: No defects were found

Surface Condition: Satisfactory

Low Risk: 5

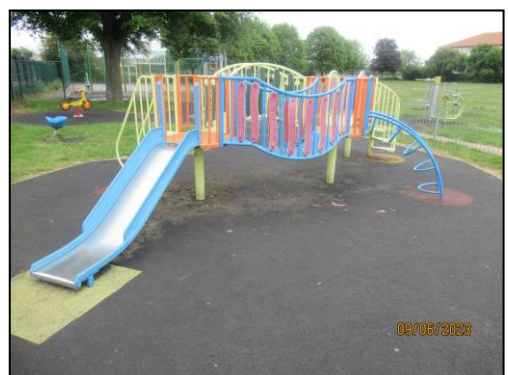
5. Hags Toddler Multi Unit

Condition: No defects were found

Surface Condition: Satisfactory

Low Risk: 4

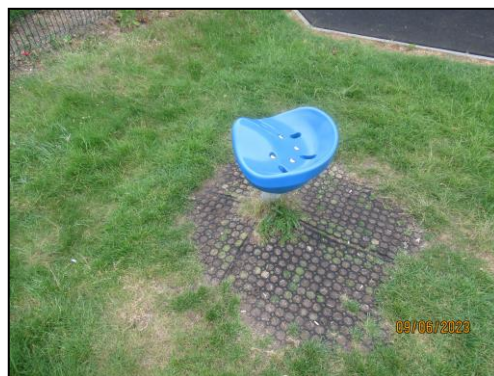
6. Hags Rota Seat

Condition: No defects were found

Surface Condition: Satisfactory

Very Low Risk: 2

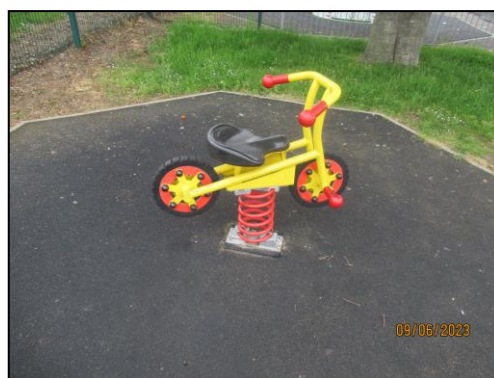
7. Sutcliffe Spring Bike

Condition: No defects were found

Surface Condition: Satisfactory

Very Low Risk: 2

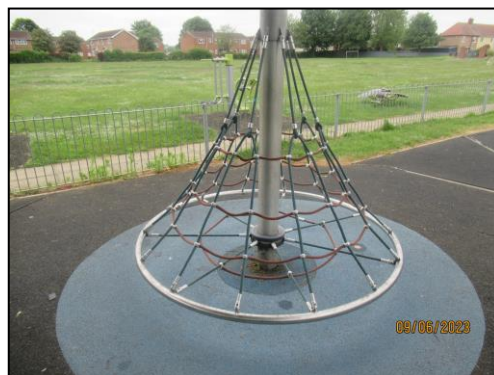
8. Tayplay Rota Net

Condition: No defects were found

Surface Condition: Satisfactory

Low Risk: 5

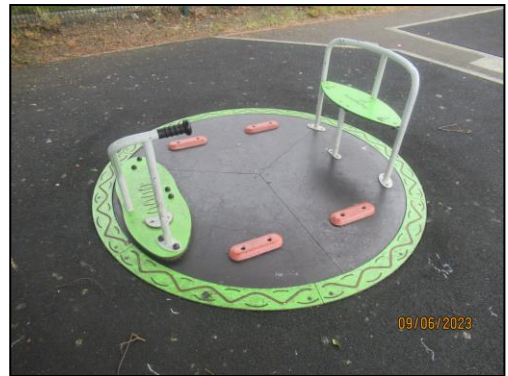
Condition: No defects were found

Surface Condition: Satisfactory

Very Low Risk: 3

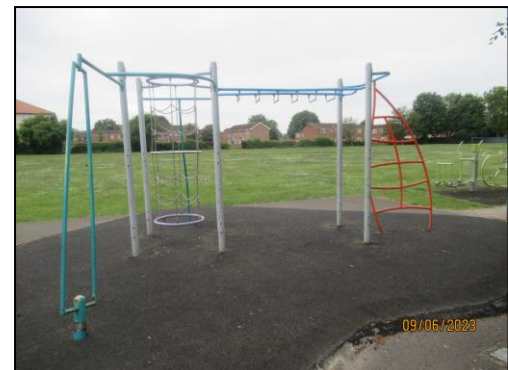
Condition: No defects were found

Surface Condition: Satisfactory

Low Risk: 7

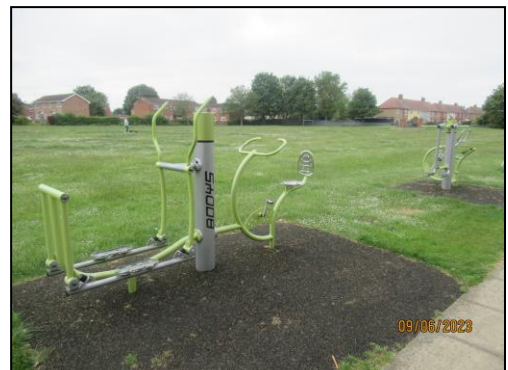
Condition: No defects were found

BS EN 16630, Sec. 7.2, replace missing user instruction notices at all items

Surface Condition: Satisfactory

Low Risk: 7

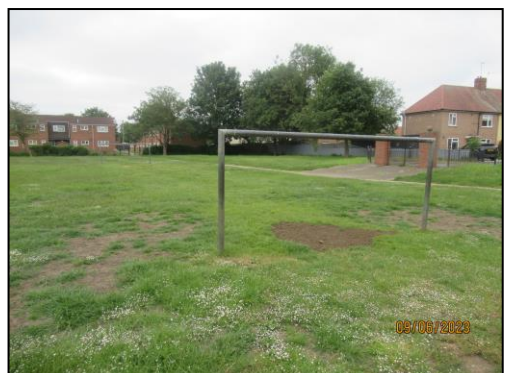
Condition: No defects were found

Surface Condition: Worn in goals – monitor

Medium Risk: 8
